Study on Recycling of Cooling and Freezing Appliances Containing Vacuum Insulation Panels (VIPs)

Partner:
Montanuniversitaet Leoben,
Department of Environmental and Energy Process Engineering
Chair of Waste Processing Technology and Waste Management
(AVAW)
Franz-Josef-StraÙe 18
8700 Leoben

April 2014

CECED European Committee of Manufacturers of Domestic Equipment

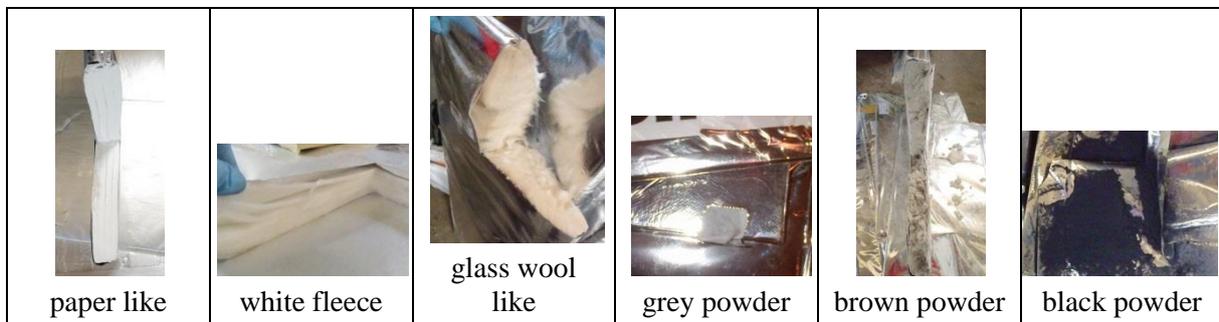
- Material group 1 (paper like), received from VIPS-4, VIPS-6, VIPS-10, VIPS-14;
- Material group 2 (white fleece), received from VIPS-4;
- Material group 3 (glass wool like), received from VIPS-13;
- Material group 4 (grey powder), received from VIPS-15;
- Material group 5 (brown powder), received from VIPS-7, VIPS-10;
- Material group 6 (black powder), received from VIPS-9.

Figure 1: Different Material Groups of the Vacuum Insulation Panels

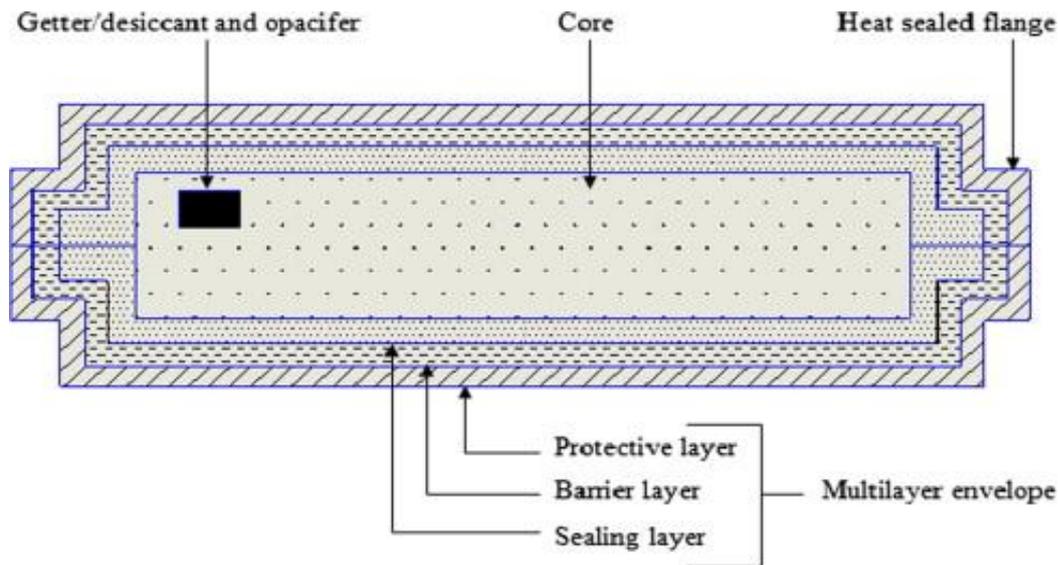
- Multilayer envelope (prevention of air inlet);
- Highly-porous core material, e.g. fibreglass (stabilisation against atmospheric pressure);
- Getters (collection of gases leaked through the membrane to ensure vacuum).

Figure 2: Schematic of a VIP from the Building Construction Industry [Alam]

In Figure 2 the schematic of a building construction VIP is represented.

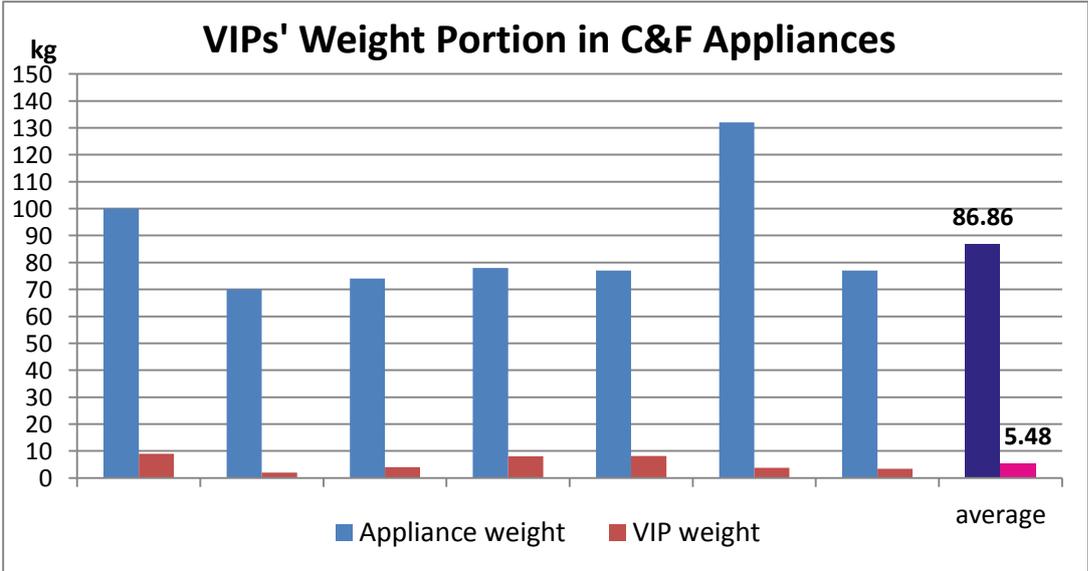
Figure 3: VIPs' Weight Portion in C&F Appliances (based on data from CECED)

The information of these two tables is also represented in two bar diagrams: Figure 3 (based on data of) and Figure 4 (based on data of Table 4). In these two following bar diagrams the calculated average weight of the appliances and of the VIPs is shown on the right side.

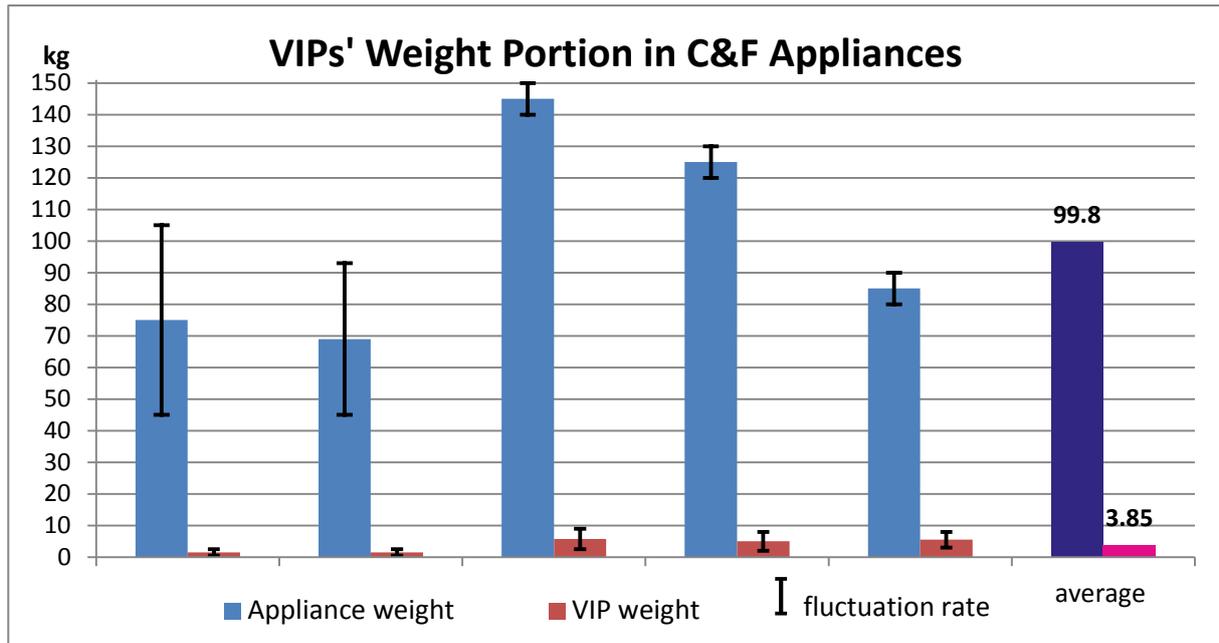
The fluctuation rates shown in the following figure are based on the minimum and the maximum weights illustrated in Table 4. Due to the wide range of the weight data, clear allocation is not possible.

Figure 4: VIPs' Weight Portion in C&F Appliances with Fluctuation Rates (based on data from CECED)

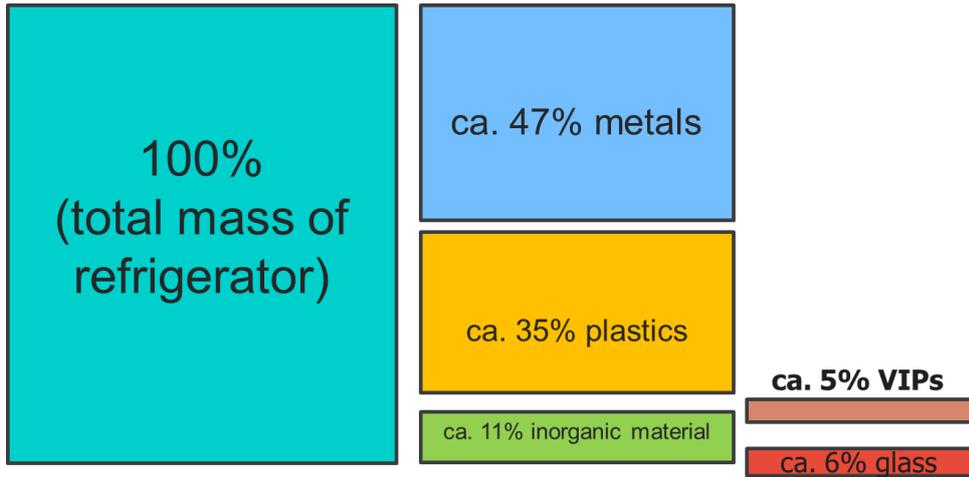
To quote the report from 2011 created by Renato Sarc and Josef Adam at Montanuniversitaet Leoben (q.v. [Sarc]), a C&F appliance of category A++ contains about 5% of VIPs (see Figure 5). This percentage is in line with the received data from CECED.

Figure 5: Mass Balance of C&F Appliances Based on an A++ Cooling Appliance [Sarc]

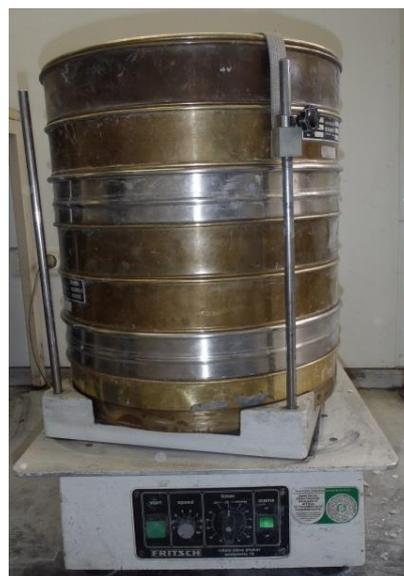
Figure 6: Sieve Tower on Mechanical Shaker

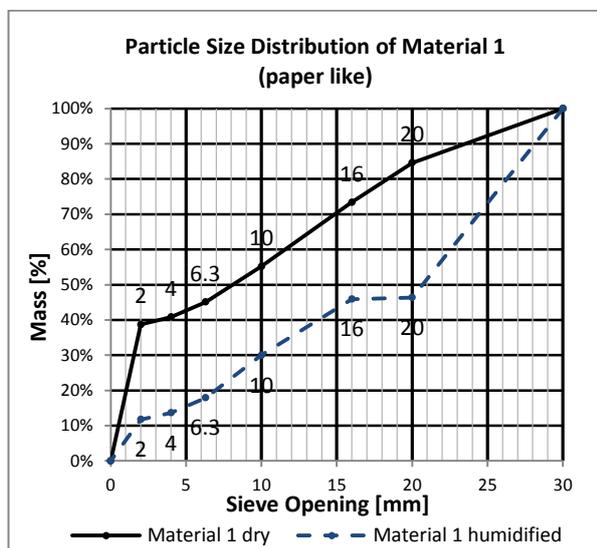
Figure 7: Particle Size Distribution of MG1

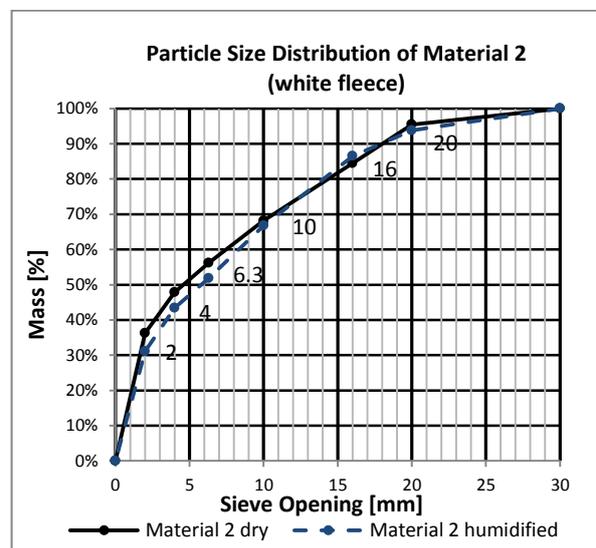
Figure 8: Particle Size Distribution of MG2

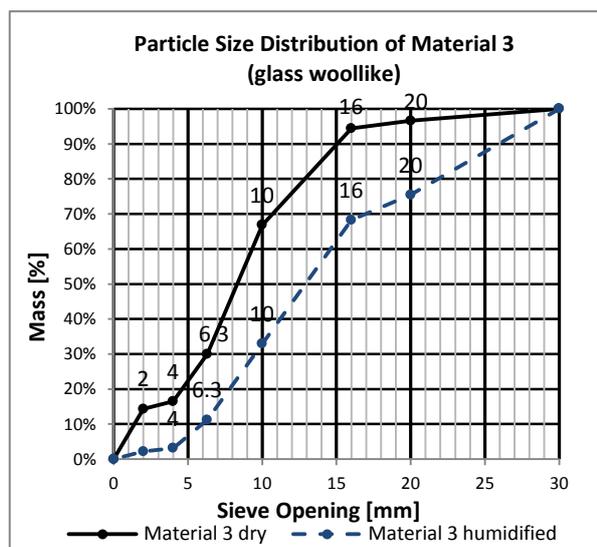
Figure 9: Particle Size Distribution of MG3

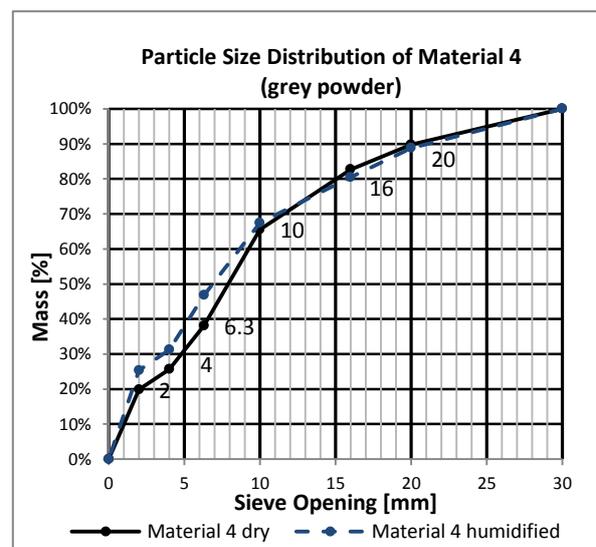
Figure 10: Particle Size Distribution of MG4

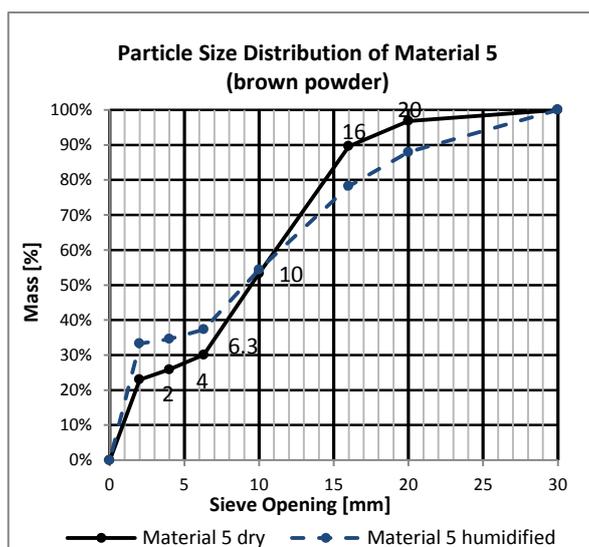
Figure 11: Particle Size Distribution of MG5

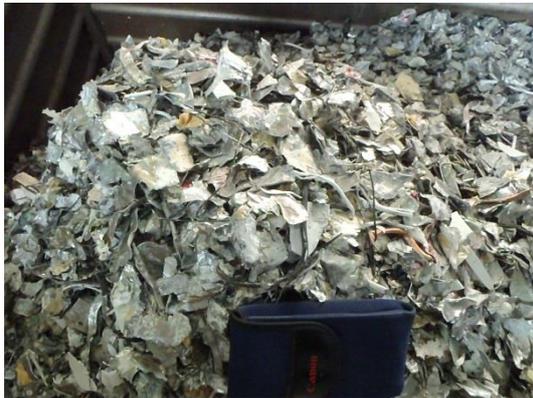
Neither changes in the output fraction “metal” (see Figure 13) nor changes in the output fraction “plastics” (see Figure 14) could be determined during the run of this material group. It can be assumed that all VIPs’ components (aluminium foil as well as core material) got in the PU fraction. The treatment of MG1 did not cause any technical problems in the plant.

Figure 13: Output of Metals

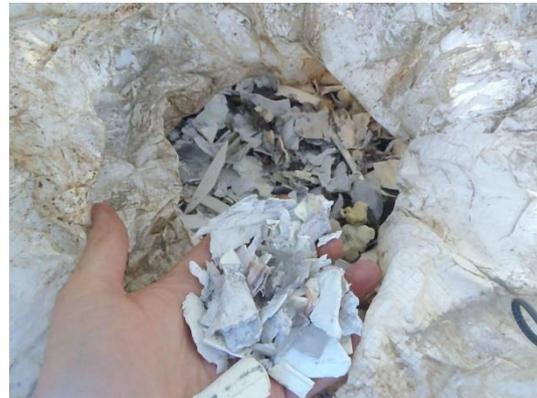
Figure 14: Output of Plastics

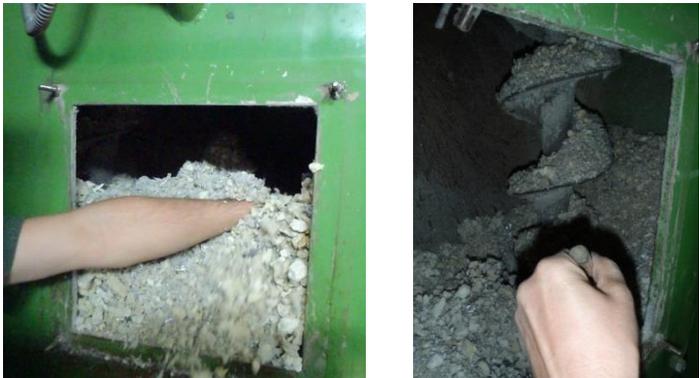
While shredding this material, an increase of its volume could be determined by a camera, installed inside the shredder. This also happened during the small-scale shredding test. However, the effect was not as big as expected, which can be explained by the vacuum in the entire system. All VIPs’ components of MG3 were found like the components of the other material groups in the PU output. At this point some problems in the unit occurred, where the already shredded PU foam is transported by a screw (the so called discharge screw). There

was a blockage, caused by the glass wool fibres. The material tended to form bridges inside the discharge screw. This was the reason why the screw was blocked. The unit had to be opened and cleaned manually, which is obvious in Figure 17.

Figure 17: Opening and Cleaning of the Blocked Screw Discharge (3 Pictures)

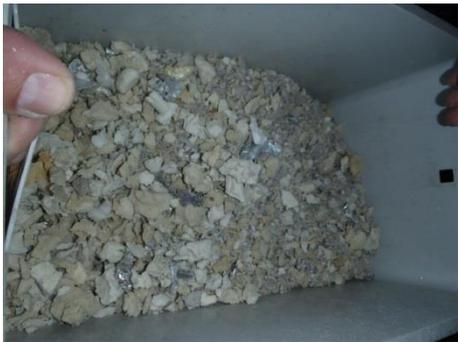
The output fraction “PU-foam” also contained aluminium foils and core materials of MG3, which can be seen in Figure 18. A summary of the test with MG3 in TP1 is given in Table 21.

Figure 18: PU Output Mixed Up with VIPs’ Material

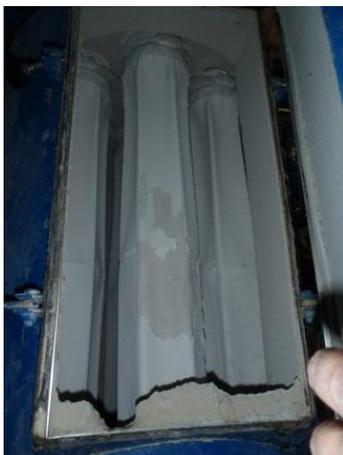
The installed paper filter was equipped with a new filter paper just one week before the test. Furthermore, the filter system was complemented by a new cyclone filter unit. Despite this new filter, dust (in combination with air humidity) was bounded on the filter surface as well as on the inner surface of the feed hose. Due to the heavy deposits on the paper filter (according to the facility manager “these amounts of dust do not even occur after one month of normal operation”), a conventional cleaning by counter pressure was not possible. The filter had to be cleaned manually. The deposits in the feed hoses had a greasy characteristic, because of the high humidity. The other units of the exhaust air system had to be cleaned too. In

Figure 20: Deposits on paper filter

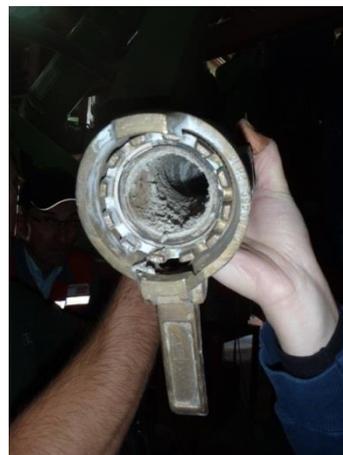
The core material of MG4 is very powdery and fine-grained, what caused a heavy formation of dust inside the plant. Due to the dust, it was soon impossible to see anything on the camera, installed inside the shredder. With every input of an appliance into the shredder, dust streamed into the preparing hall. After about 20 minutes, the dust inside the hall caused a smoke alarm.

Figure 21: Deposits in feed hose

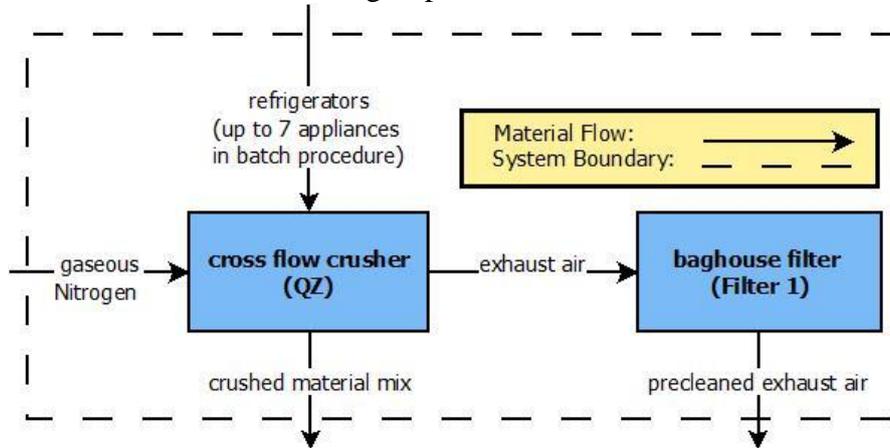
which is activated about every 20 seconds. A schematic diagram of filter 1 is given in Figure 24. The measured values of filter 1 were read during the entire test (irregular intervals). Chapter g) will deal with the measure values of the filter in detail. In the following subchapters each run of the six material groups are described.

Figure 24: Schematic Diagram of the Bag House Filter (Filter 1) Directly Behind the QZ

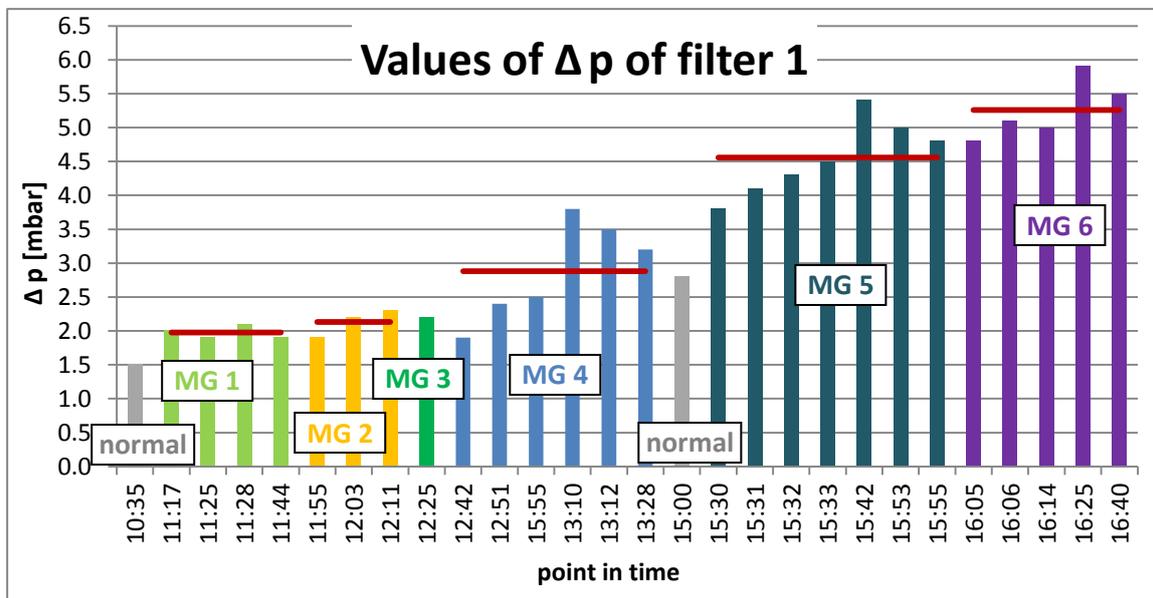
In Figure 31 it is obvious, that the differential pressure Δp , measured at filter 1, is clearly higher during the shredding processes of MG4, MG5 and MG6 than in normal operation. However, this did not cause any problems for the operation in the plant. It is important to know, that the chains inside the cross flow crusher had been changed just before the test started. The plant had to be opened, which caused atmospheric pressure in the plant during the exchange of the chains. After this maintenance of the QZ, nitrogen was injected in the plant again and vacuum had to be built up again. In the course of the day, Δp of filter 1 was increasing, which also can be confirmed by the two “normal” measurements (first at 10:35, second at 15:00).

Figure 31: Measurement of Differential Pressure of Filter 1 during the Large-scale Test in TP3 (Red Lines: Average Values)

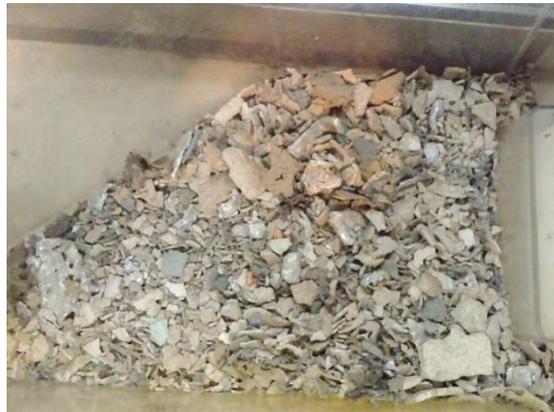
The components of all VIP types could neither be found in the non-ferrous fraction (see Figure 32) nor in the ferrous fraction. Hence, it can be assumed, that all components of the vacuum insulation panels went to the PU output, which also makes sense regarding the

Figure 32: Non-ferrous Output (TP3)

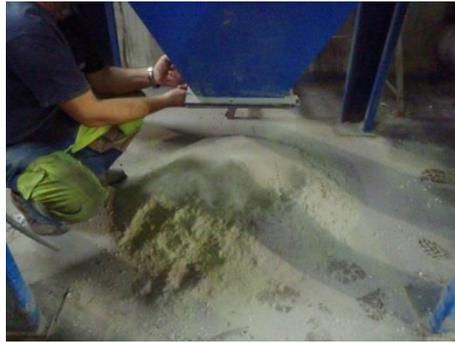
Figure 41: Residue on the Filter directly behind the Shredder

The amounts of the residue of the filter directly behind the shredder (see Figure 41) were according to the production manager clearly bigger than the dust amounts of a normal operation. It was a mixture of PU foam and core materials of the VIPs. This mixture was also found in the PU silo (see Figure 42).

These previous pictures illustrate, that the present plant, TP10, is not ready for treating the powdery VIPs in huge amounts. Some modulations (better dust filter systems, bigger exhaust air flow etc.) would be necessary to make the plant ready for MG4, MG5 and MG6. After the three powdery material groups, MG2 was treated as last test material. While the shredding process of MG2, the amount of dust inside the plant was decreasing; although some dust particles wafted through the air, which were visible in flash light. After all VIPs of the six material groups had been treated in the plant, it was possible to stop the plant and open the filters. There, as assumed, the VIPs’ components together with the PU foam were found.

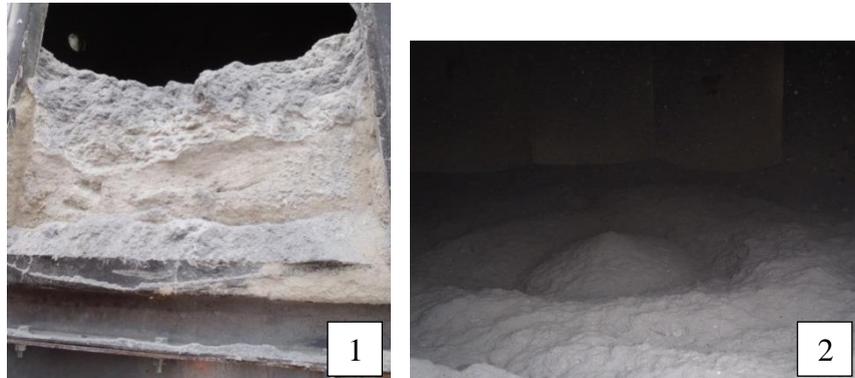
Figure 42: PU Output Mixed up with VIPs' Components
(1: Layers of different Materials; 2: Interior of PU Silo)

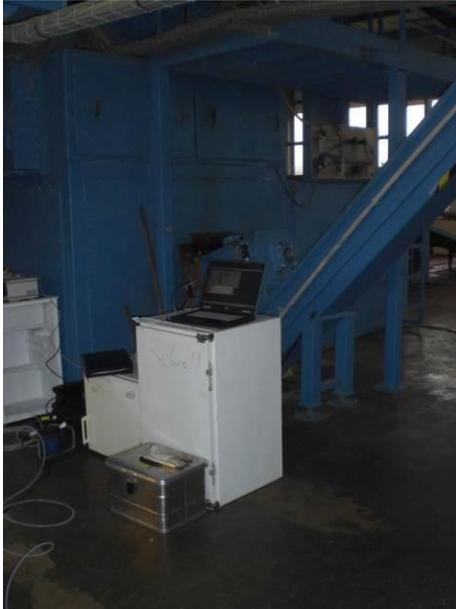
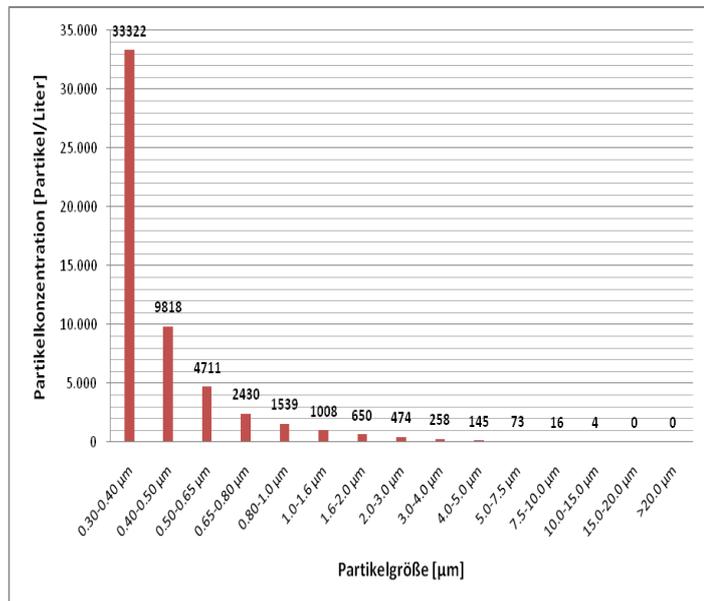
Location 1 Screw conveyor to cross-flow shredder

The chart shows half-hour averages.

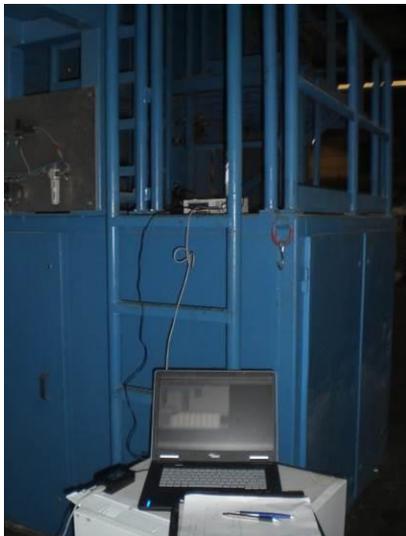
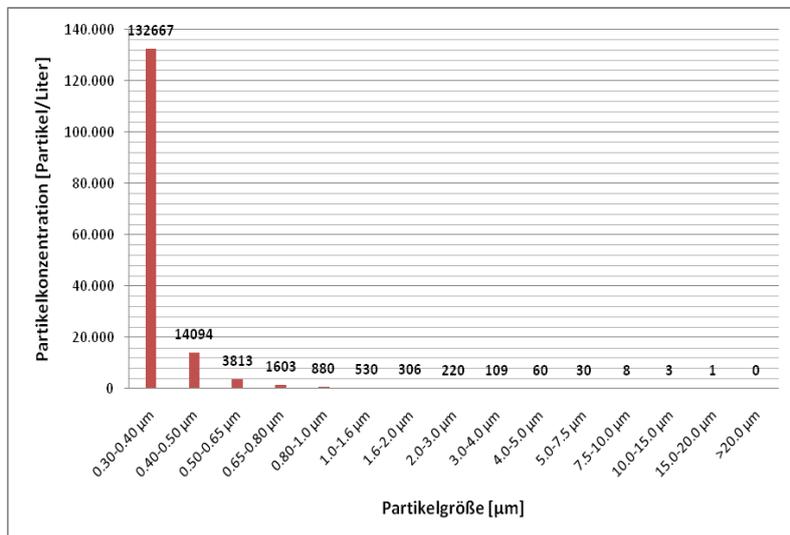
Location 2 Pre-shredder, bottom

The chart shows half-hour averages.

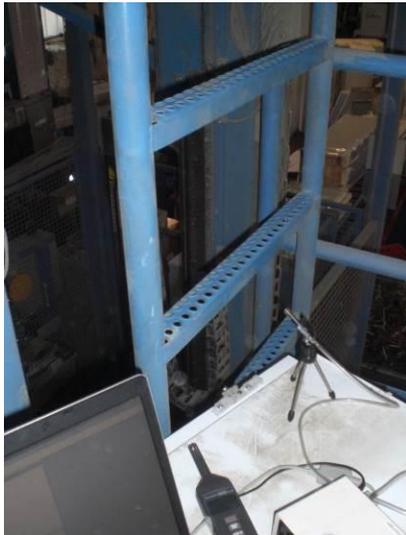
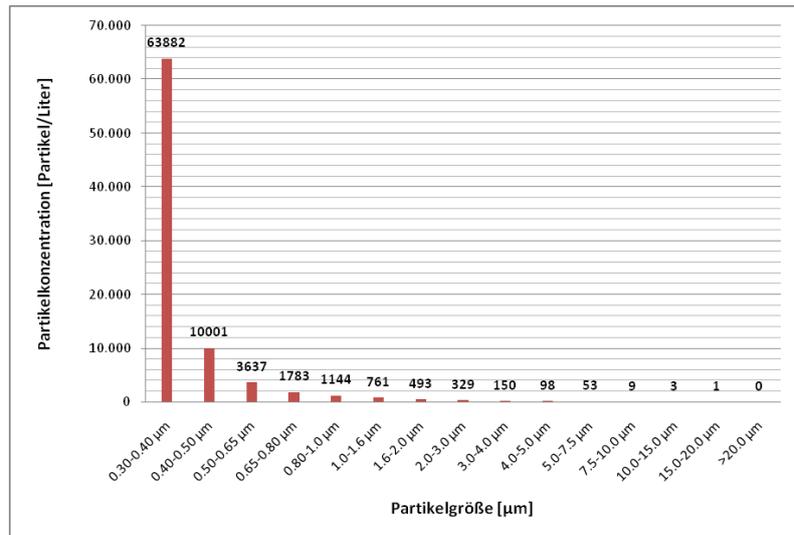
Location 3 Conveyor, top

The chart shows half-hour averages.

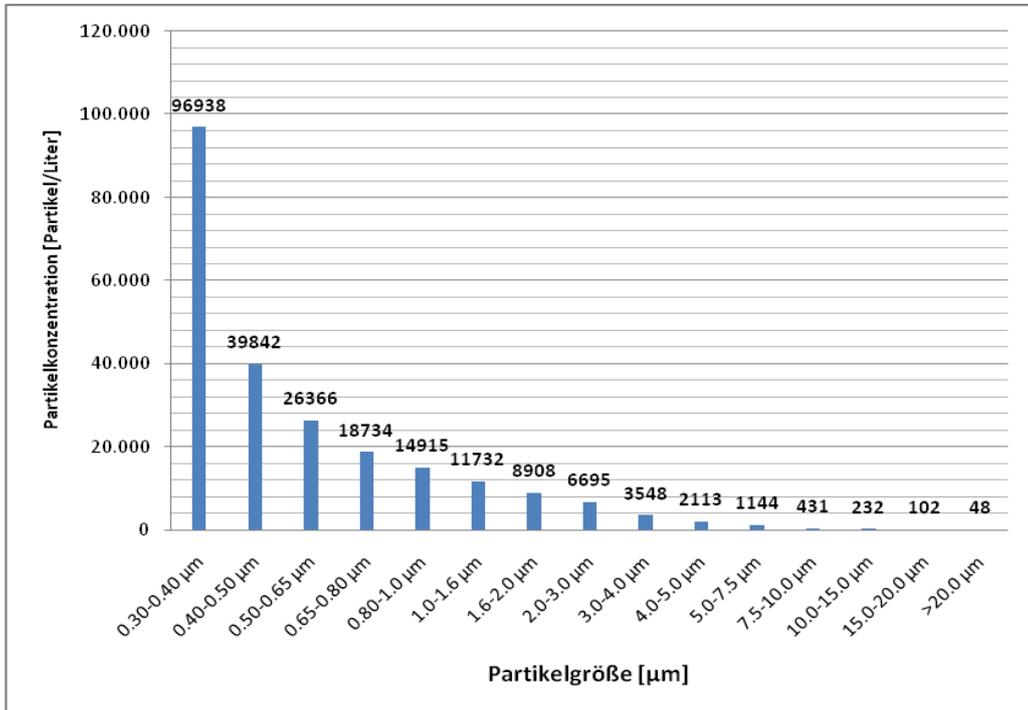
The chart below shows the averaged measurements during a time period of 2 minutes after the processing of approx. 10 to 15 refrigeration appliances with VIP.

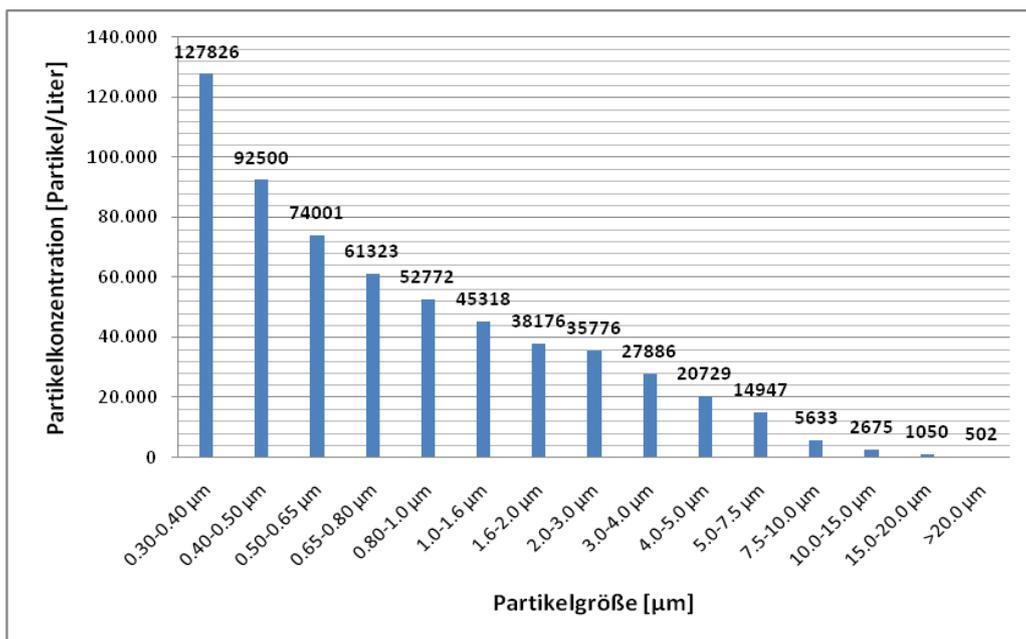
The chart below shows the averaged measurements during a time period of 2 minutes after the processing of a further 10 to 15 refrigeration appliances with VIP.

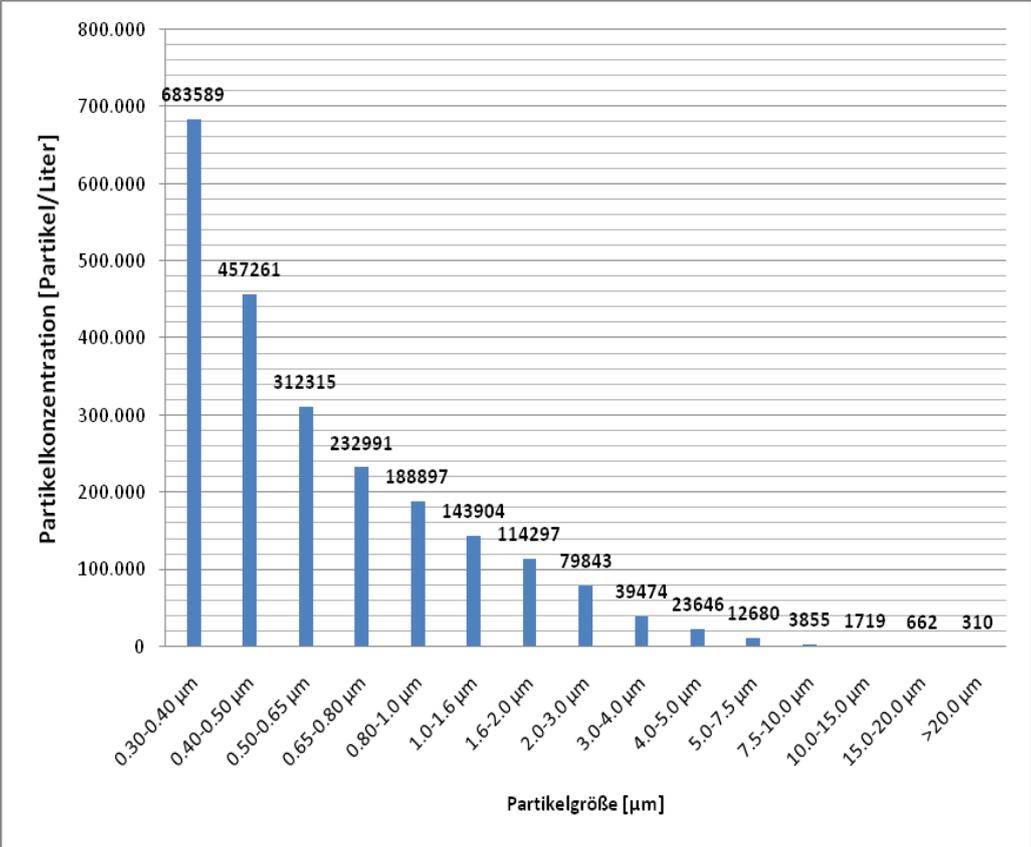
The chart below shows the averaged measurements during a time period of 2 minutes shortly before the end of processing of Batch 1.

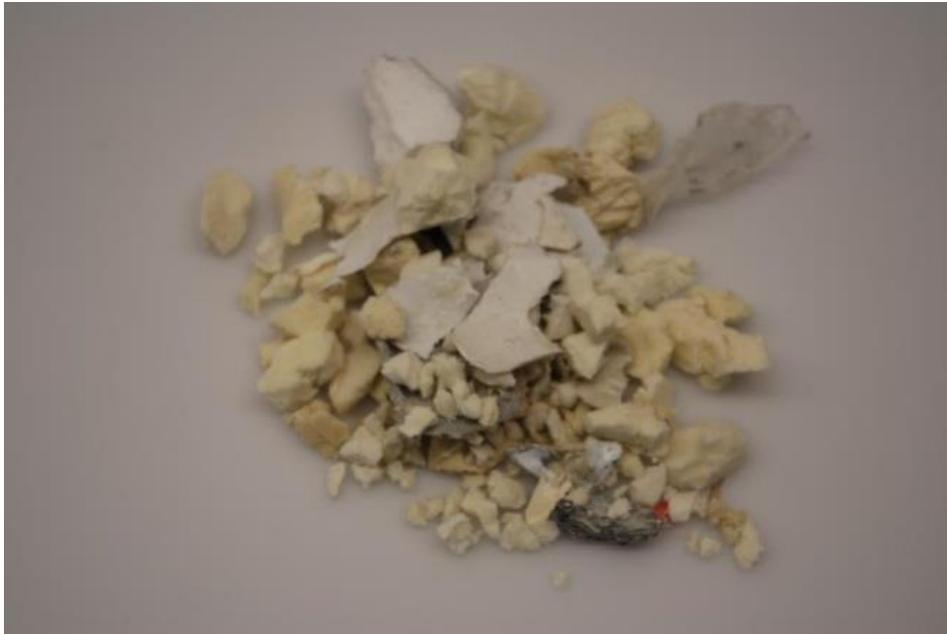
Sample 1 prior to trial. Sample taken at: screw conveyor after pre-shredder

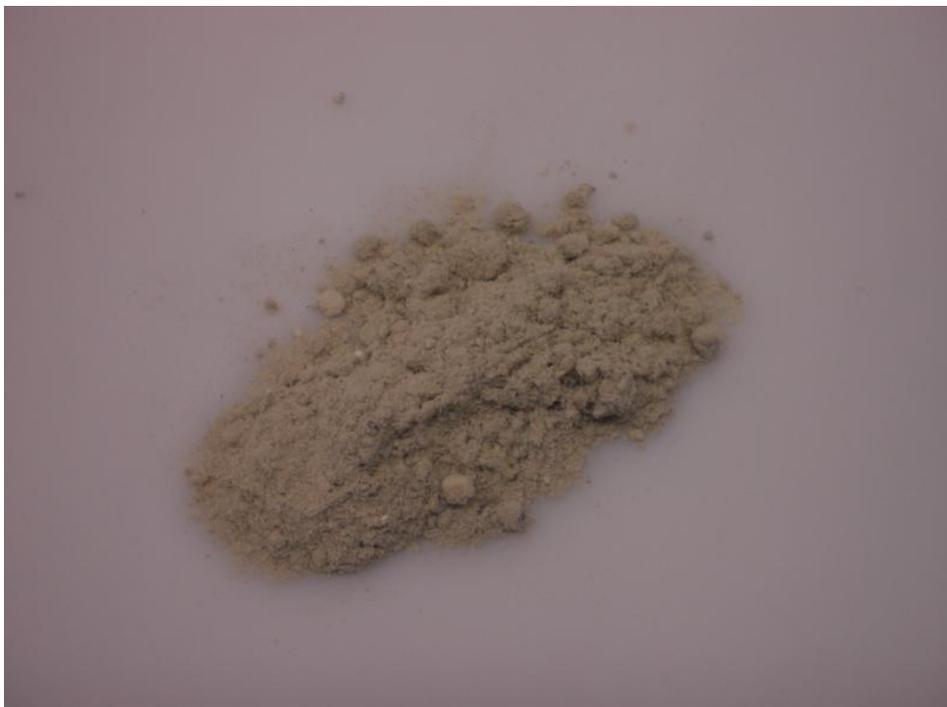
Sample 2 prior to trial. Sample taken at: screw conveyor cross-flow shredder

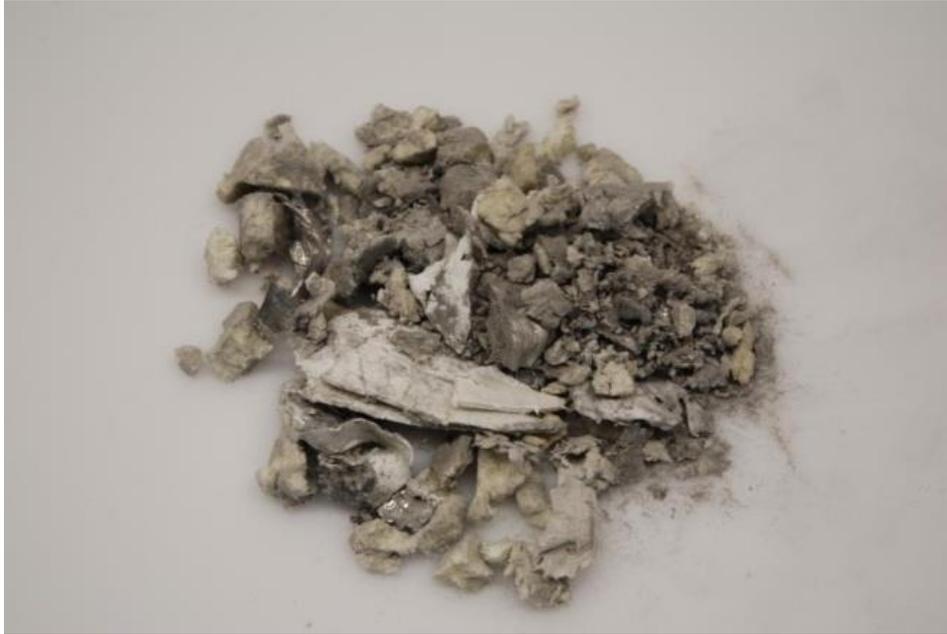
Sample 3 after 20 to 25 refrigeration appliances with VIP. Sample taken at: screw conveyor after pre-shredder

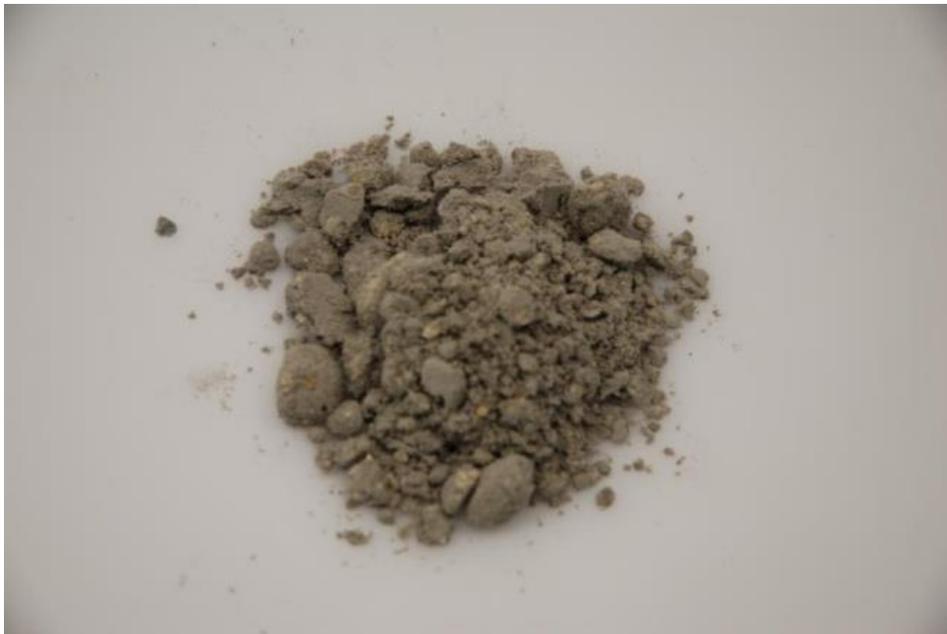
Sample 4 after 20 to 25 refrigeration appliances with VIP. Sample taken at: screw conveyor cross-flow shredder

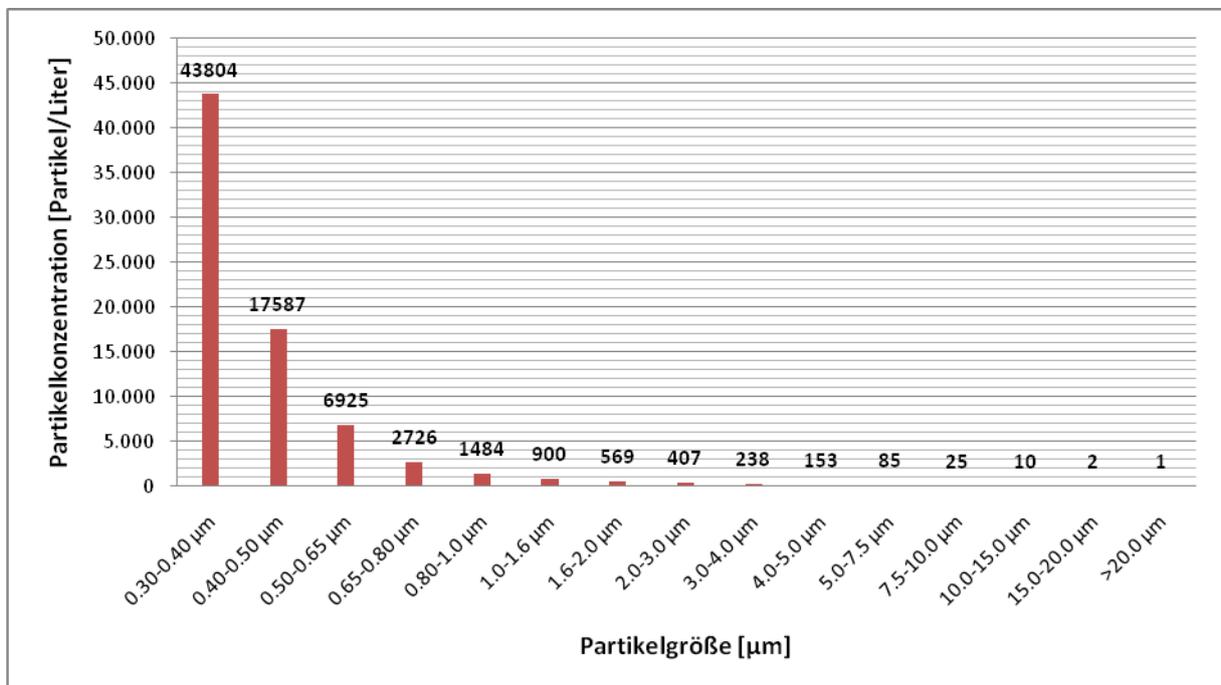
The chart shows half-hour averages.

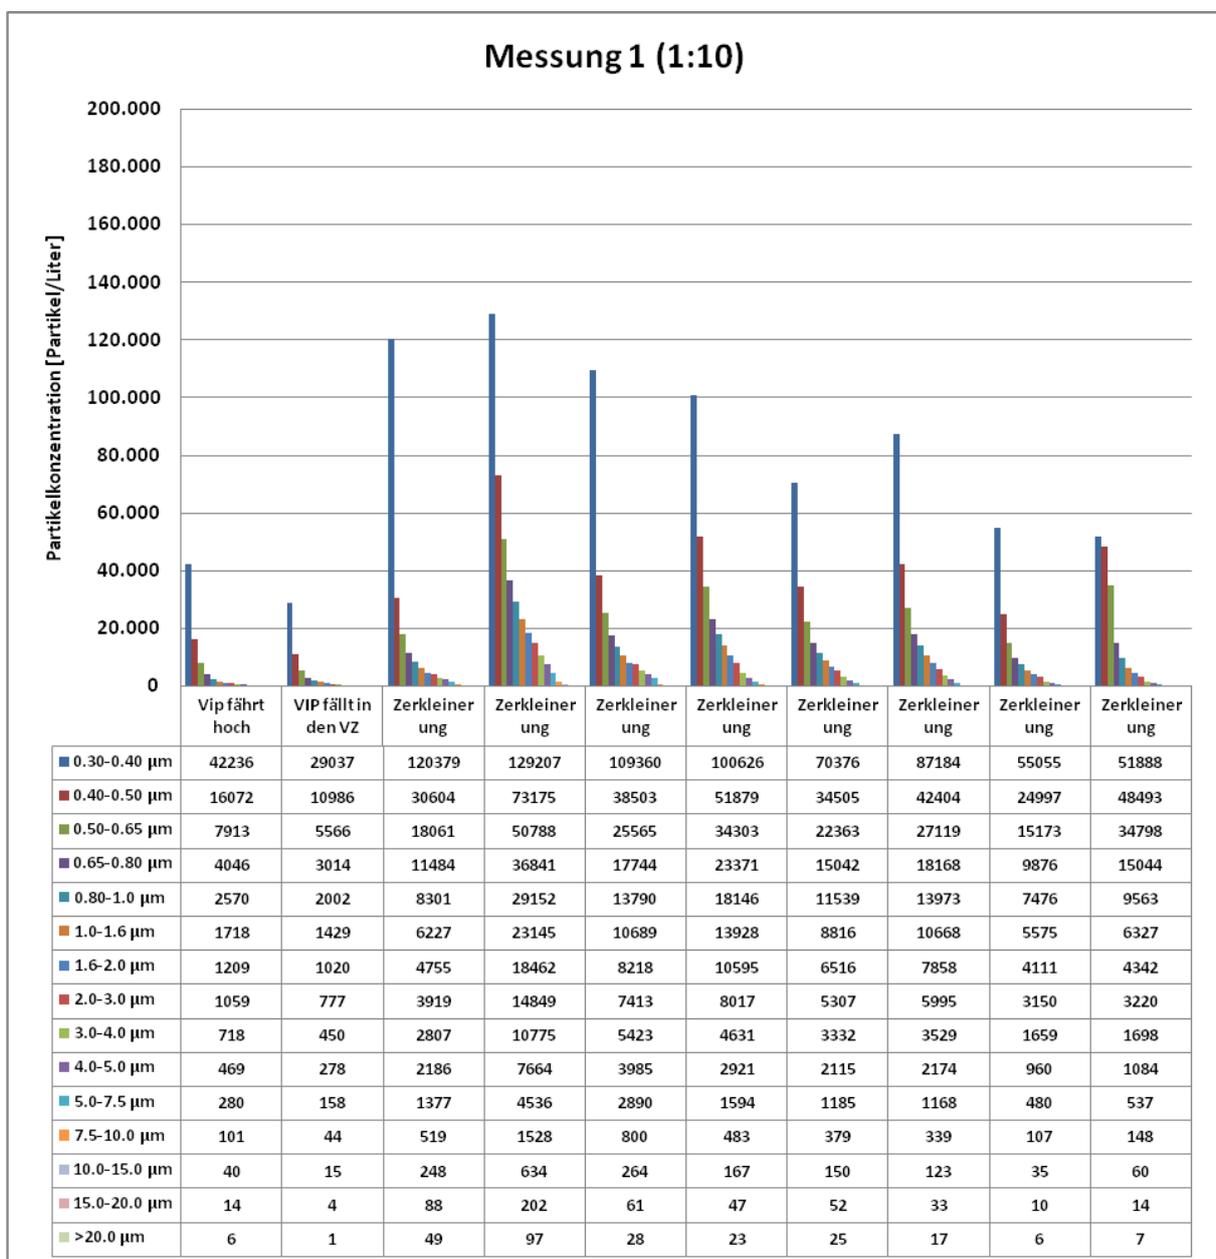
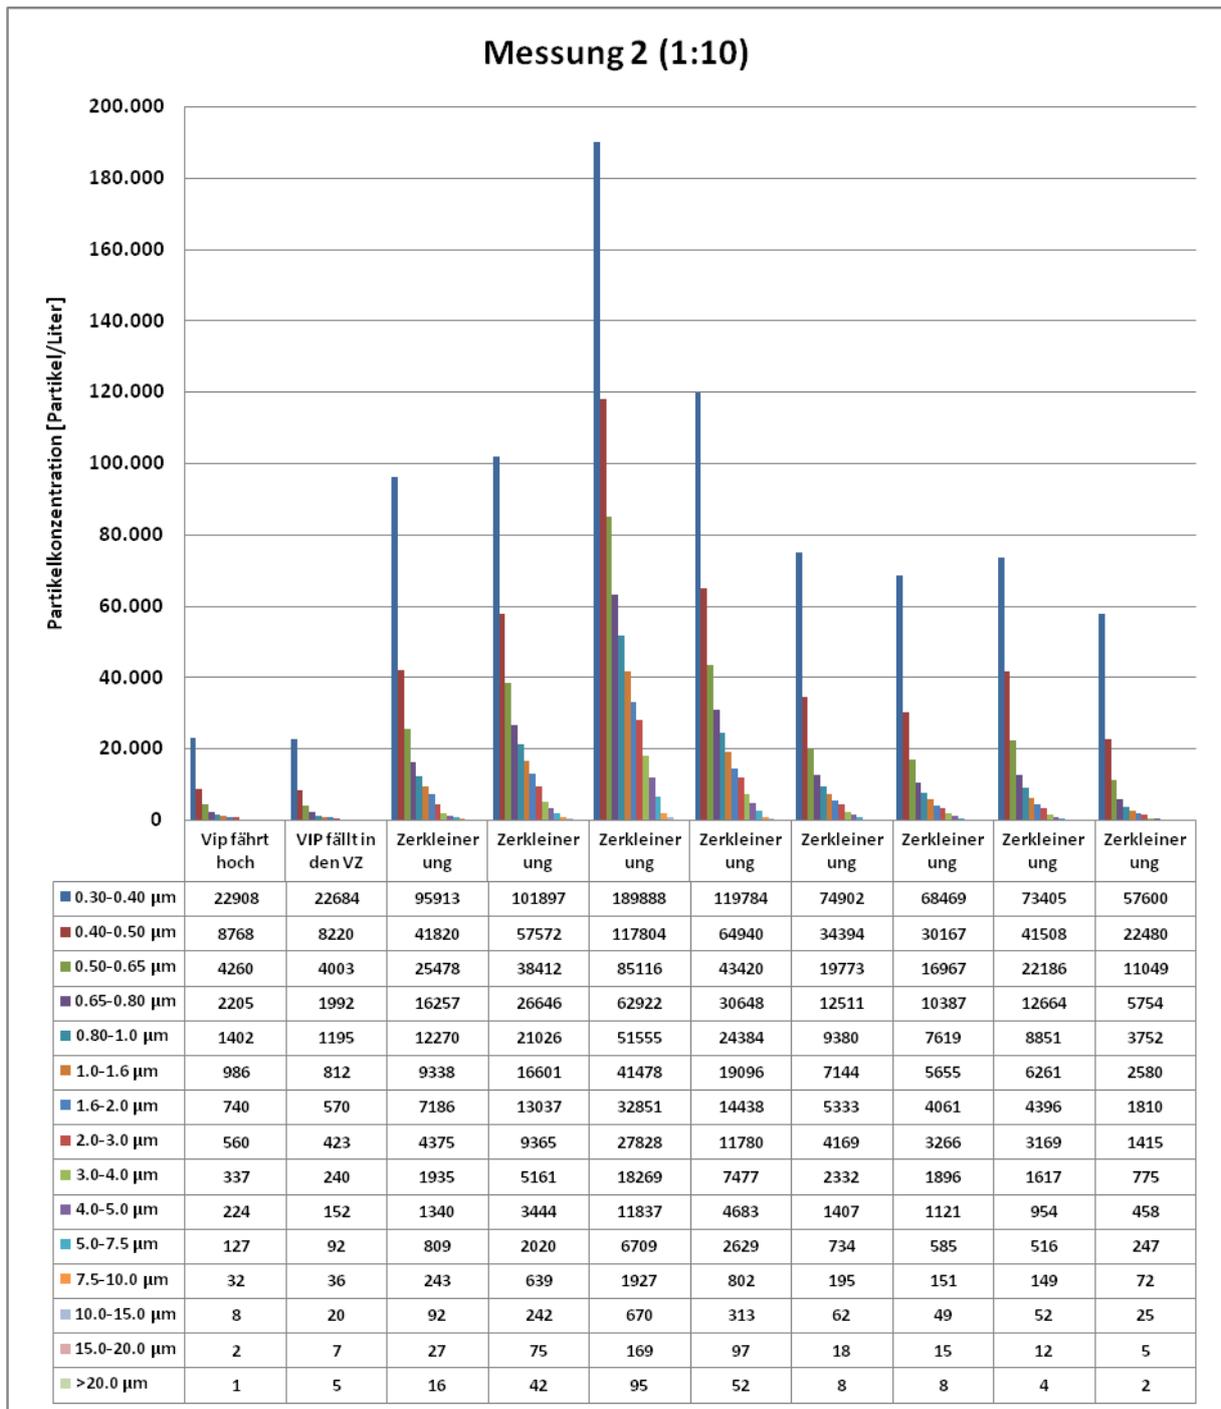
The first chart shows the emissions during the first processing run, the second one the last processing run with the combination ratio.

Taking into account the baseline measurement, both charts show that the size of the emissions and the decay curves follow similar curves. No significant increase in dust emissions can be detected between the first and last processing runs.
