Study on Recycling of Cooling and Freezing Appliances Containing Vacuum Insulation Panels (VIPs)

Partner:
Montanuniversitaet Leoben,
Department of Environmental and Energy Process Engineering
Chair of Waste Processing Technology and Waste Management
(AVAW)
Franz-Josef-StraÙe 18
8700 Leoben

April 2014

CECED European Committee of Manufacturers of Domestic Equipment

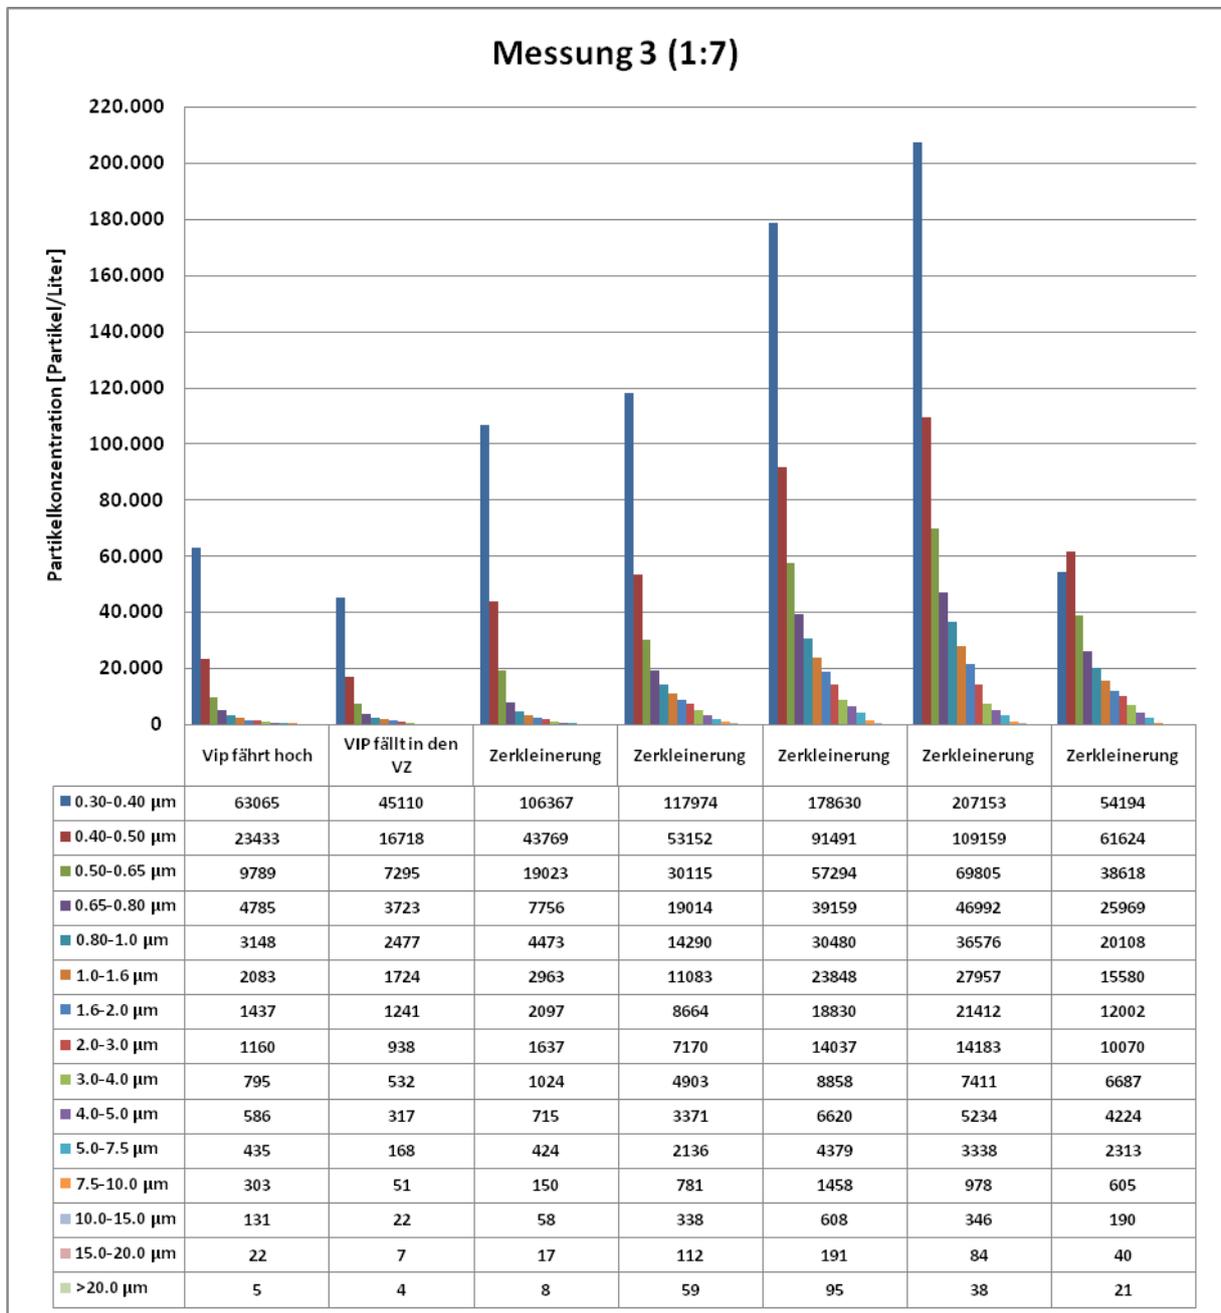
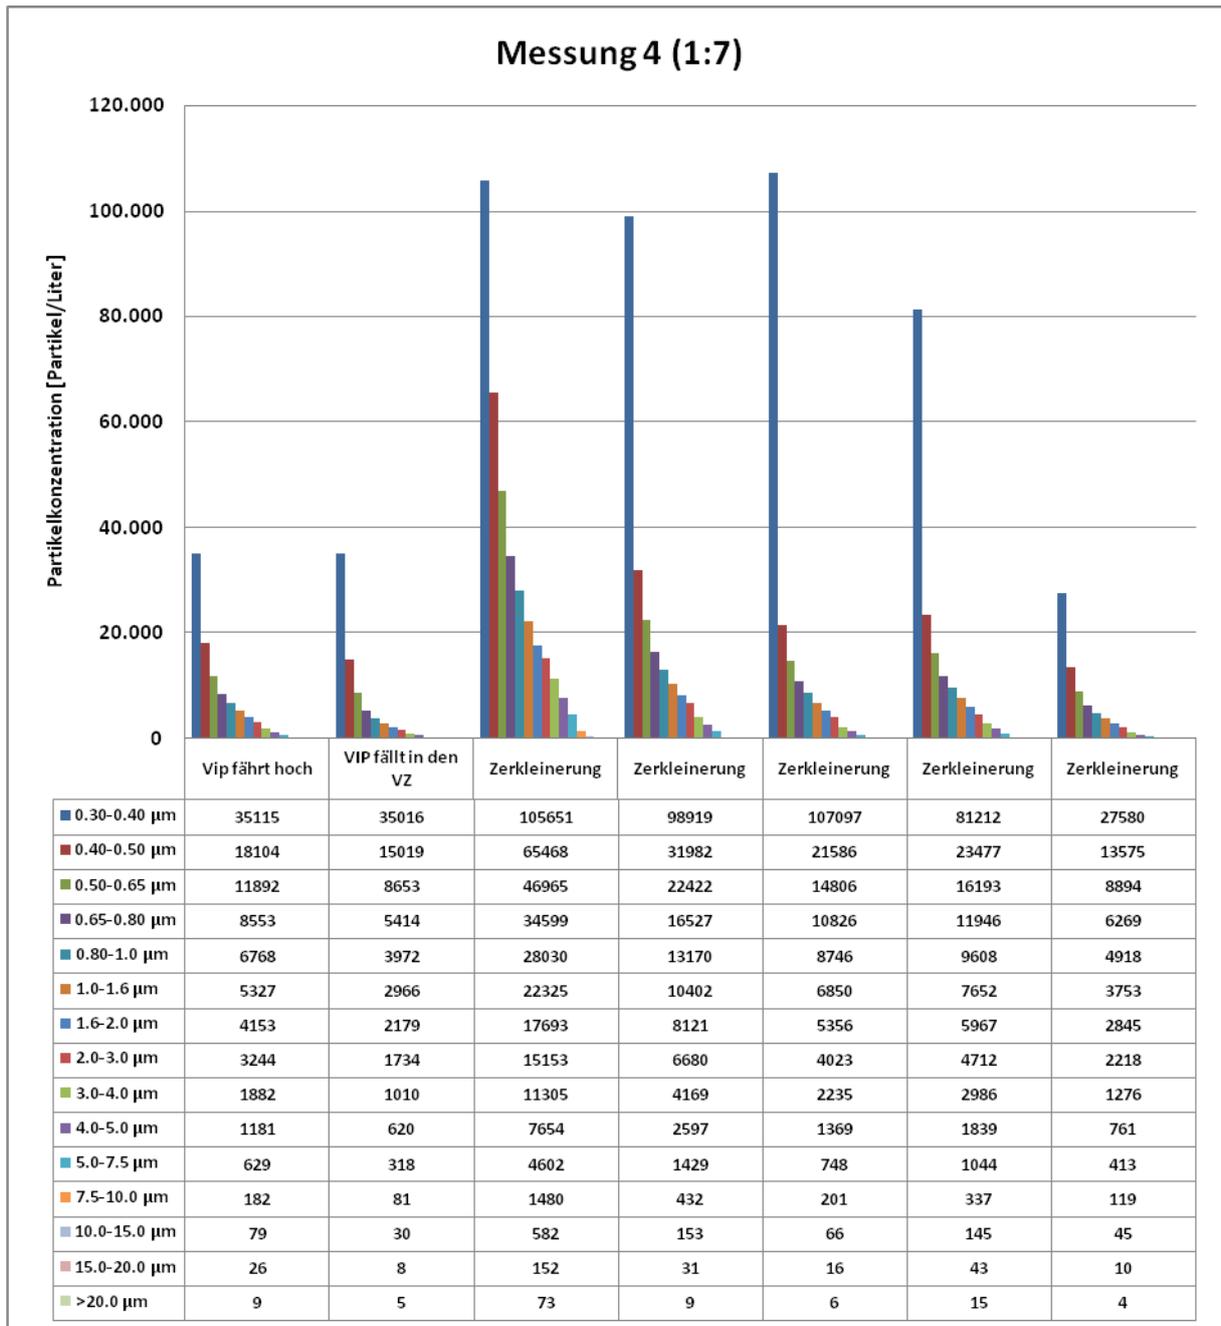
Taking into account the baseline measurement, these two charts also show that the size of the emissions and the decay curves follow similar curves. No significant increase in dust emissions can be detected between the first and last processing runs.

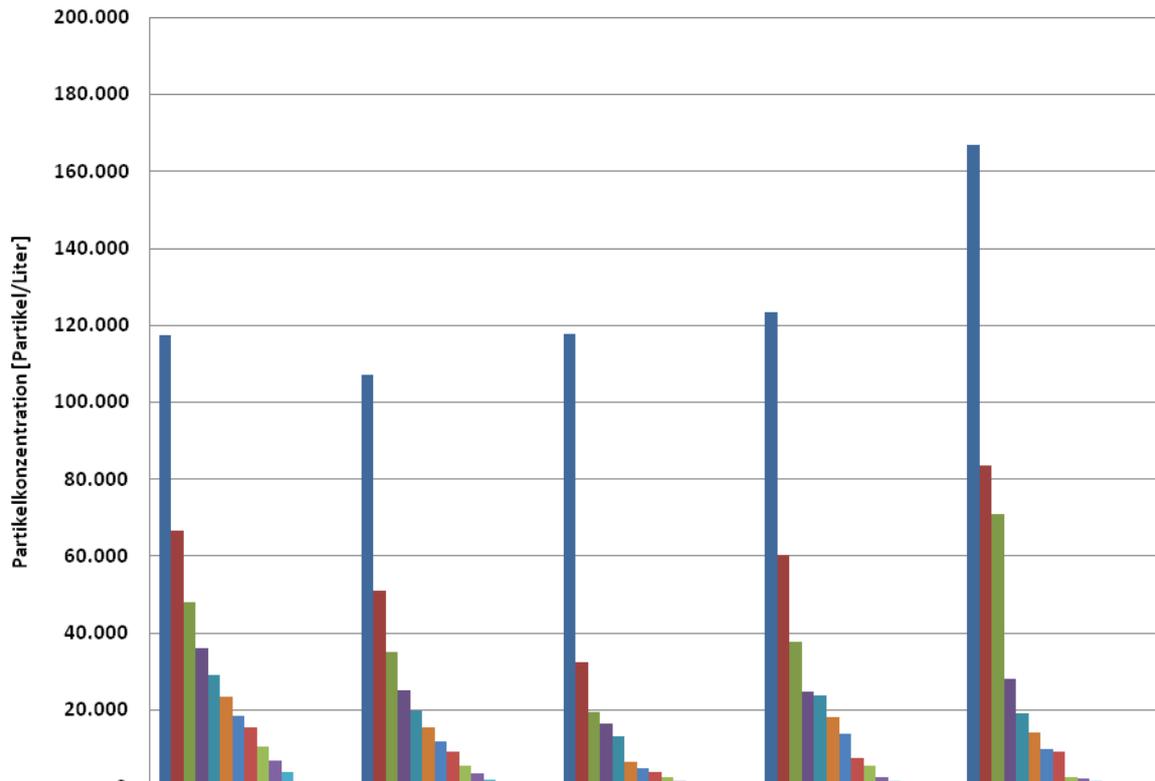
Messung 6 (1:5)

Vip fährt hoch	VIP fällt in den VZ	Zerkleinerung	Zerkleinerung	Zerkleinerung
0.30-0.40 µm	117367	107233	117670	123387	166796
0.40-0.50 µm	66582	51164	32606	60450	83482
0.50-0.65 µm	47931	35246	19356	37900	70806
0.65-0.80 µm	36174	25217	16514	24811	28112
0.80-1.0 µm	29200	19939	13084	23714	19279
1.0-1.6 µm	23487	15577	6462	18191	14218
1.6-2.0 µm	18566	12034	4895	13990	9837
2.0-3.0 µm	15558	9152	3996	7532	9262
3.0-4.0 µm	10684	5525	2551	5546	2565
4.0-5.0 µm	7007	3571	1670	2725	2291
5.0-7.5 µm	4036	1971	969	1651	1736
7.5-10.0 µm	1237	552	320	622	1008
10.0-15.0 µm	451	191	132	294	358
15.0-20.0 µm	98	36	38	100	171
>20.0 µm	43	12	21	46	107

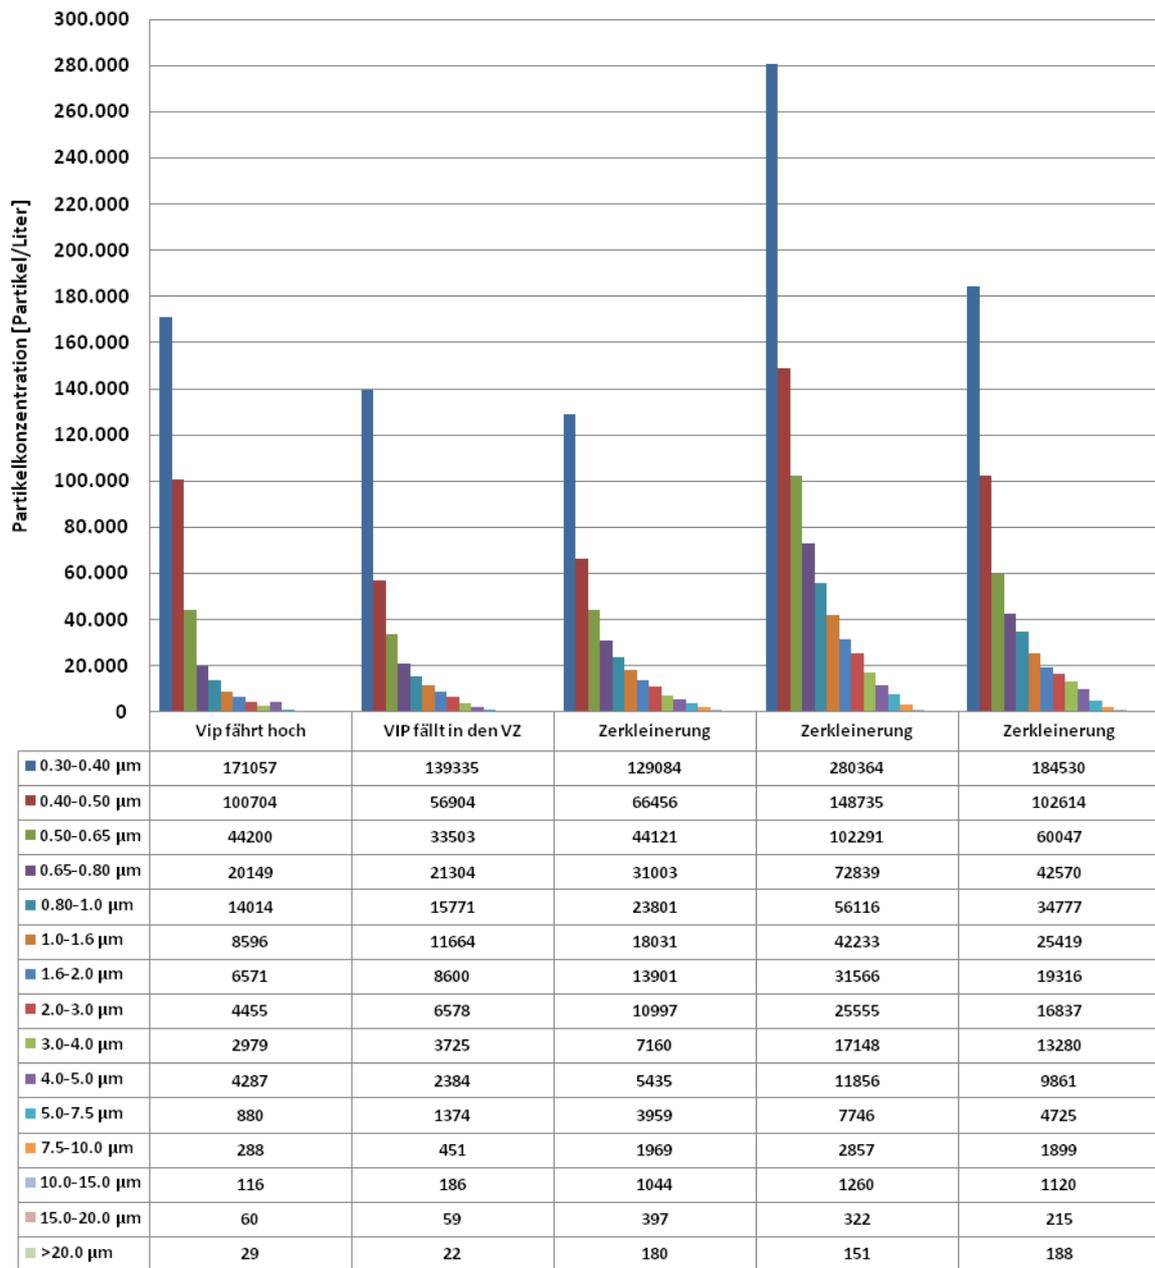
Messung 7 (1:5)

The charts clearly show a continuous increase in dust emissions as the processing run proceeds.

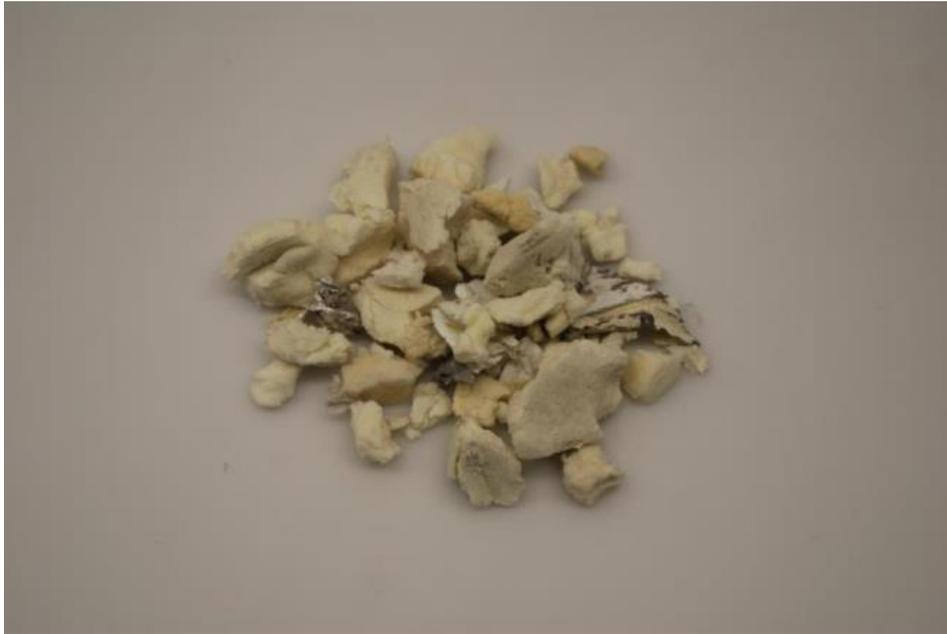
Sample 5 after 30 refrigeration appliances (combination ratio 1:10). Sample taken at: screw conveyor after pre-shredder

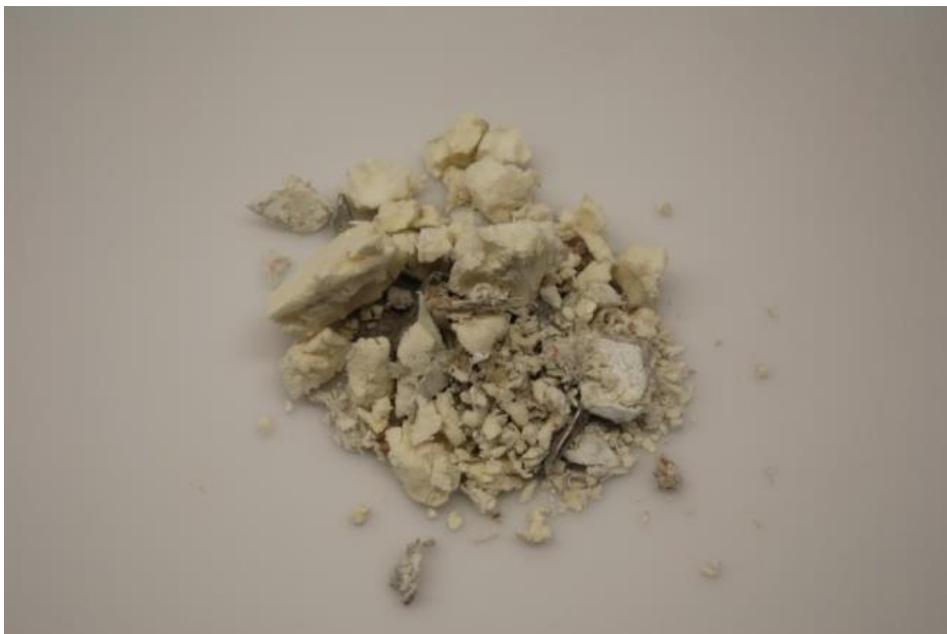
Sample 6 after 30 refrigeration appliances (combination ratio 1:7). Sample taken at: pre-shredder

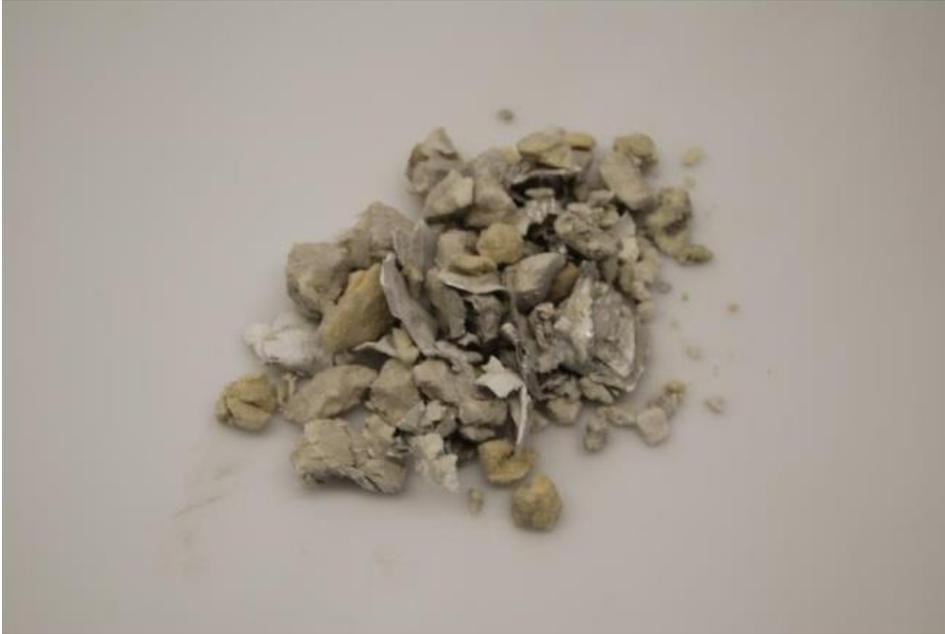
Sample 7 (combination ratio 1:5). Sample taken at: screw conveyor after pre-shredder

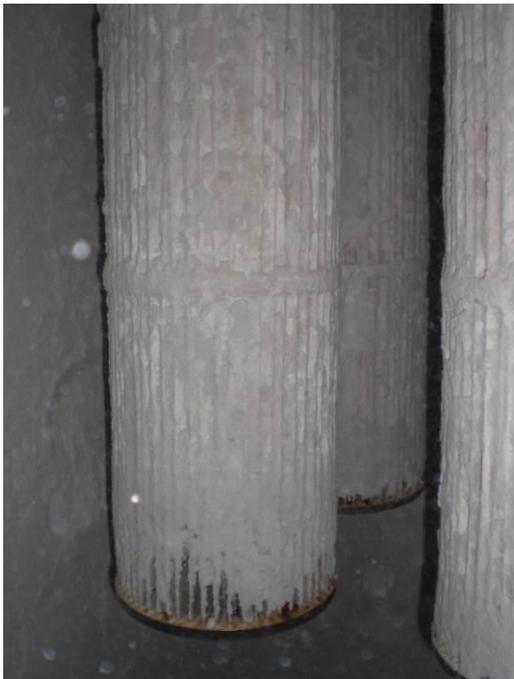
Cartridge dust filter above the cross-stream shredder before processing.

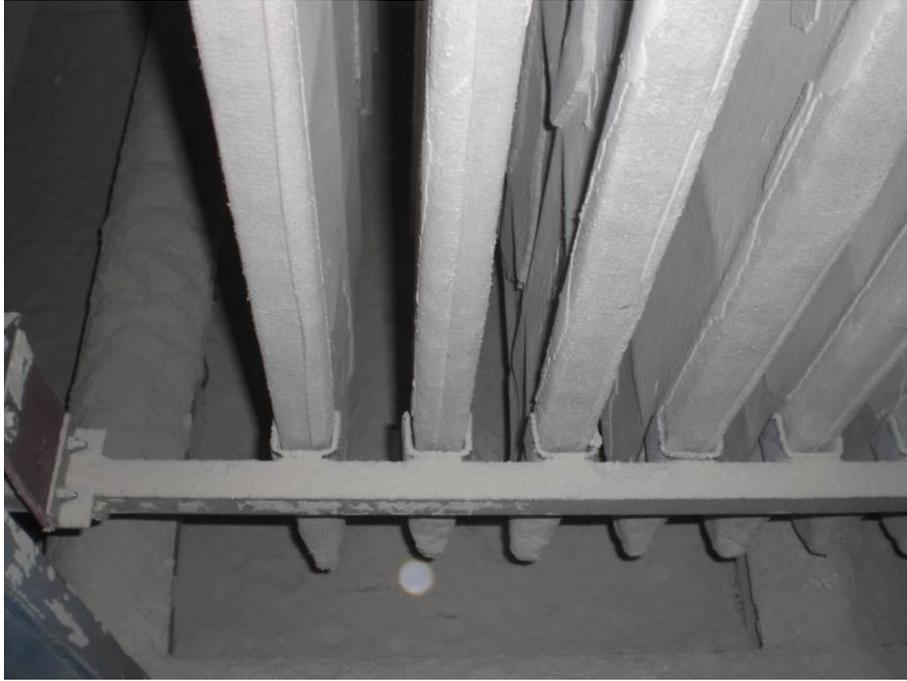
Pocket filter before processing

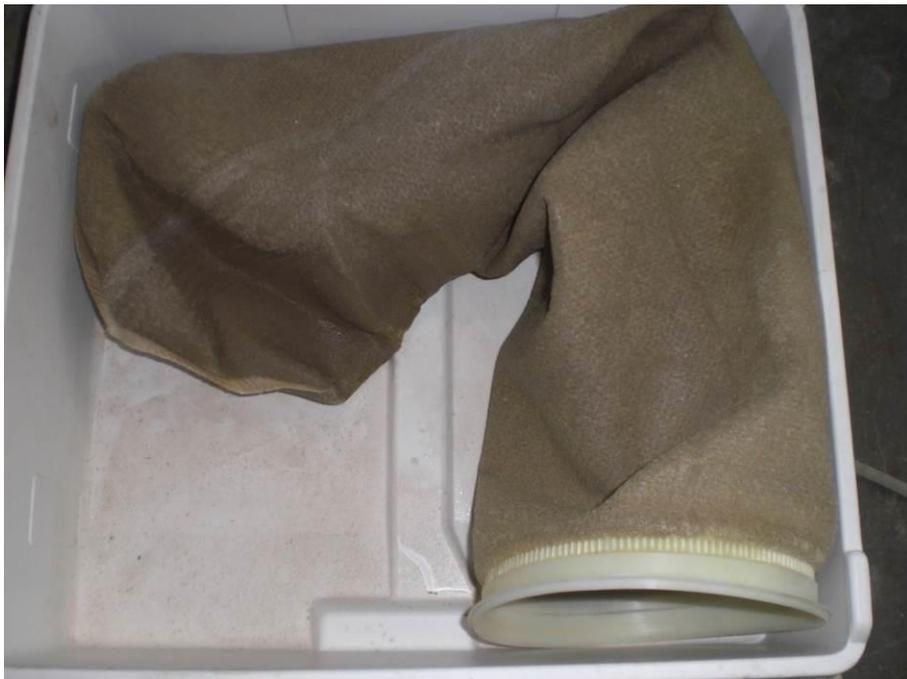
Wet filter before processing

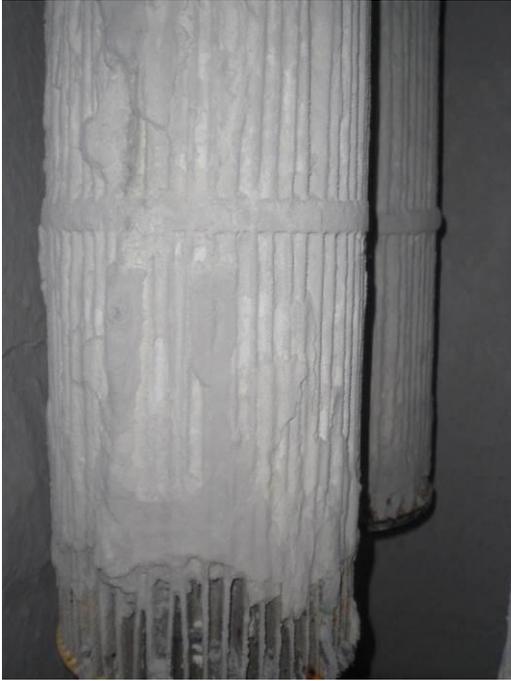
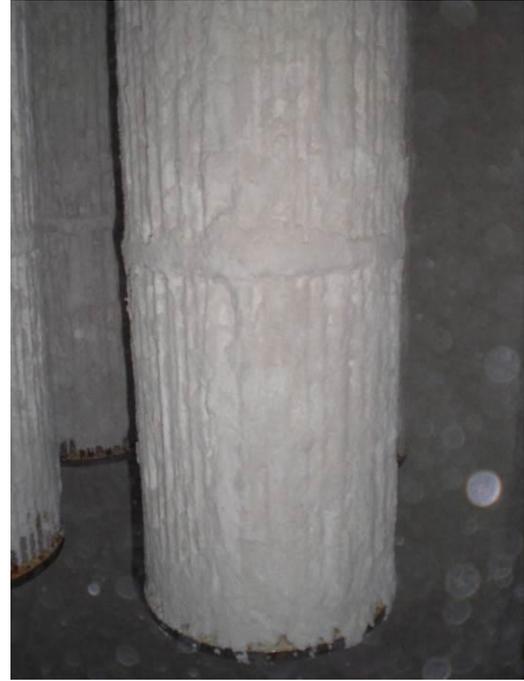
Cartridge dust filter above the cross-stream shredder after processing

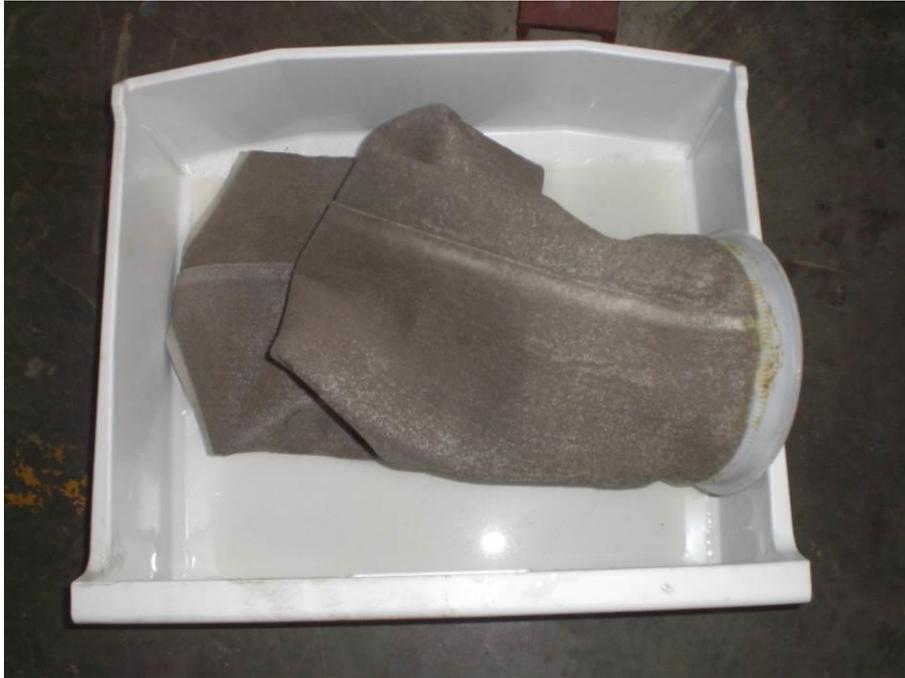
Wet filter after processing
